# The unusual events during construction

- #2 RB Flooding during Typhoon SINLAKU
- Rerouting of cables below raised floors
- Spent Fuel Pool Leakage
- RBSW AV Problems
- #1 RB Flooding during testing

## #2 RB Flooding during Typhoon SINLAKU

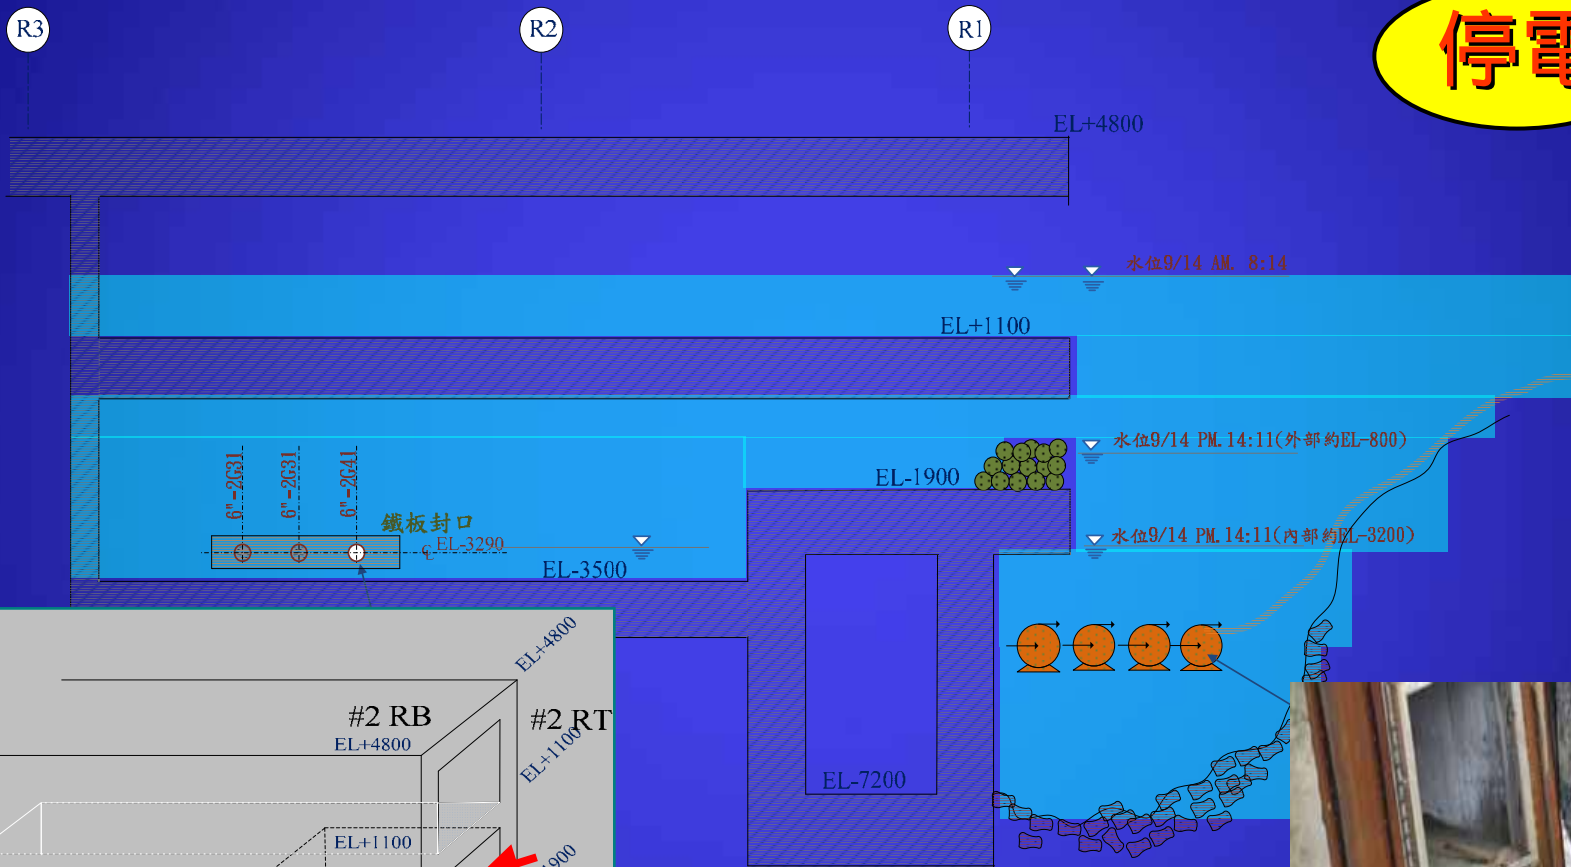
# Typhoon SINLAKU Flooding Path

- On Sep. 13<sup>th</sup> & 14<sup>th</sup> 2008, Typhoon SINLAKU hit the northern Taiwan with strong wind and heavy rains. It caused the flood in the Unit 2 Reactor Building Radwaste Tunnel of the LMNPP, which is still under construction.
- Some of the pumps failed to function due to offsite power outage in the evening of 13<sup>th</sup>. The flood level thus got higher and higher. ( outside of RB )
- The flood overflowed the sand bags and through the poorly sealed pipe ( 6 inches ) towards the RB.

- The water flew through the hole into the RB, and flooded the pumps ( not submersible pump ) equipped at the basement ( EL. -8200 ) . These 8 sets of non-submersible pump failed to function.
- The flood level eventually reached about 2 meters. ( inside of RB )

- All affected equipment have been repaired according to the recovery plan
- TPC established 「 Special maintenance plan before turnover 」 ( including Post Construction Test phase )
- TPC set up 「 Special maintenance plan after turnover 」 ( including Pre-operation test, Startup test, commercial operation phase )
- Evaluate the PCT, Pre-op, Startup test result
- Enhanced supervision for at least 2 cycles after commercial operation
- **Ensure the affected equipment can perform its intended safety function not only in testing phase but also in operating phase**

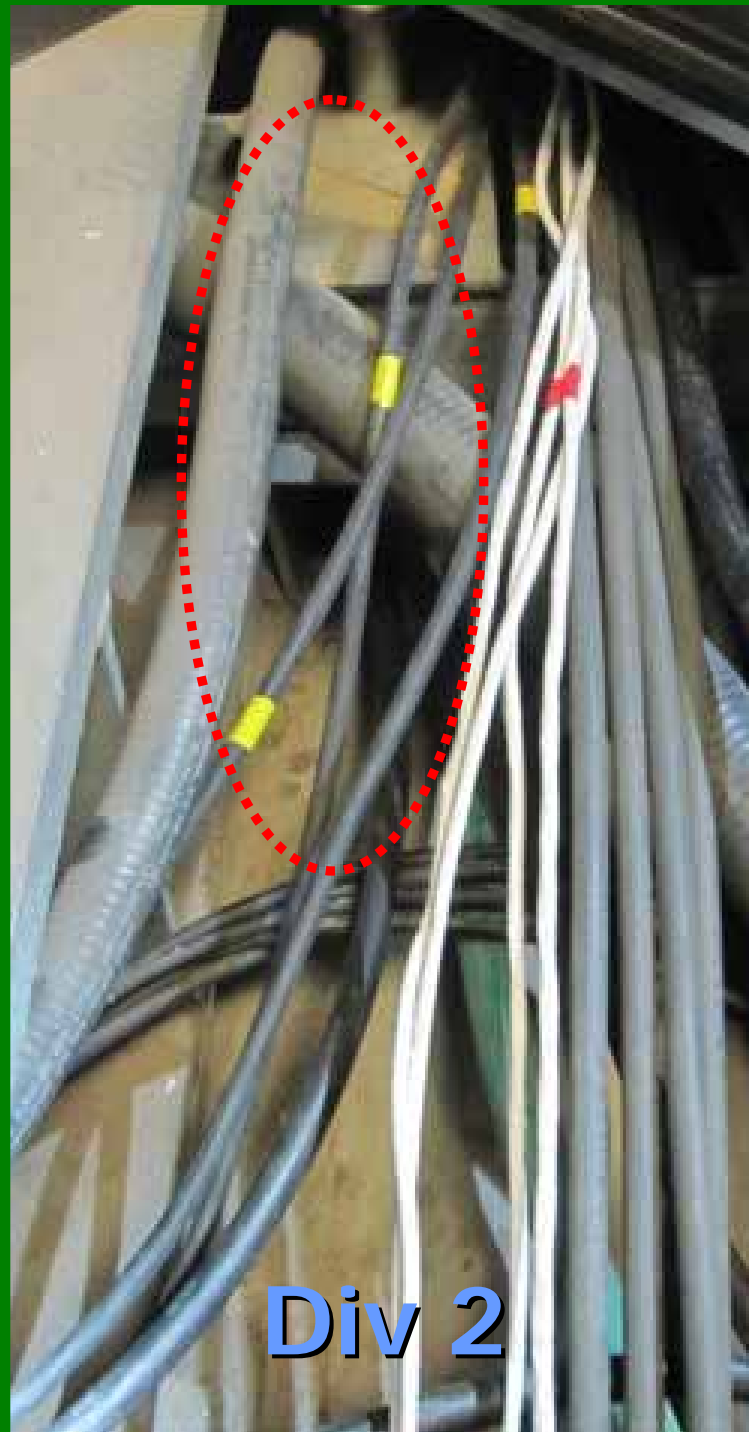
**Div 2**

- **39th Periodic Inspection conducted by AEC (June 21 ~ June 25,2010)**
- **Major Inspection Findings:**
  - **Violation of Independence and Separation criteria**
  - **Inadequate Cable Routing Condition**

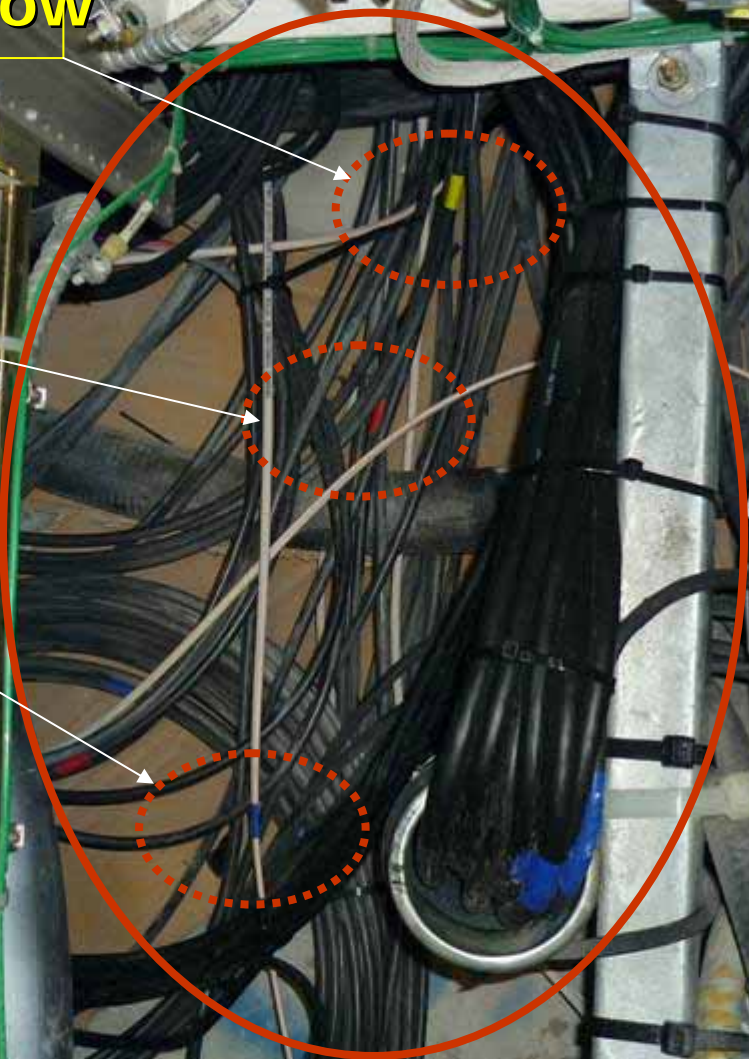
**Different divisional cables were mixed in the cabinet**

- **Corrective actions:**
  - Rerouting/Rearrangement Plan taken immediately
  - Re-inspection of cable installation in other areas
  - Enhance the training and experience feedback for workers.
  - Modifying the procedure for inspection of cable installation.
- **AEC requested TPC to conduct a review from various aspects including design, construction and installation, inspection, personnel training, engineering management and organizational culture, etc., and to investigate the cause for the defects, and submit feasible improvement plans and thoroughly implement them.**

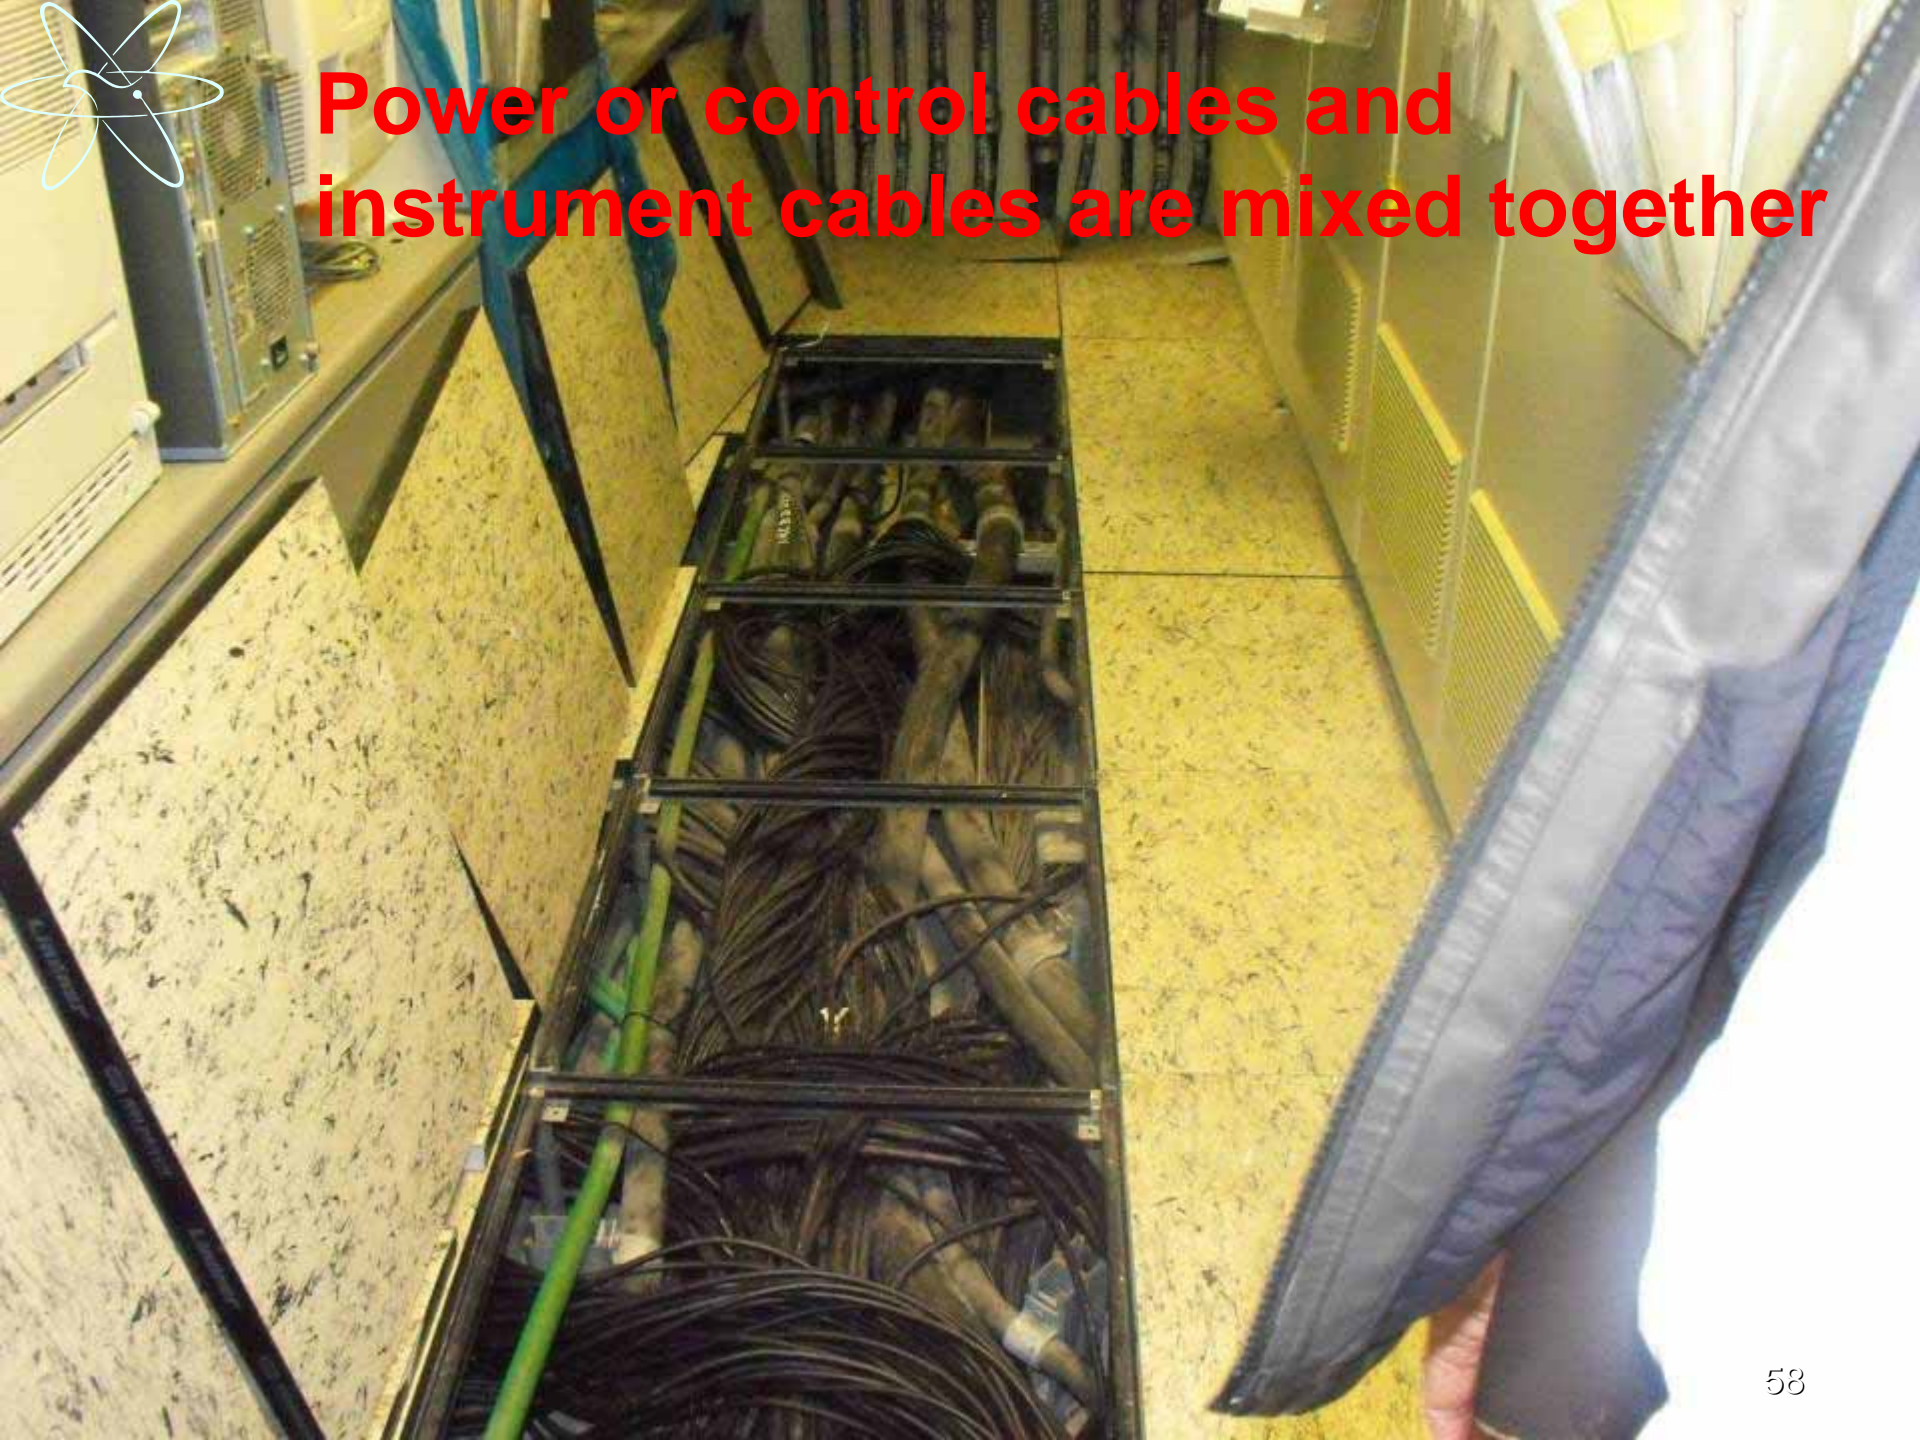
**Power or control cables and instrument cables are mixed together**

**Field Run? Free Run ?**

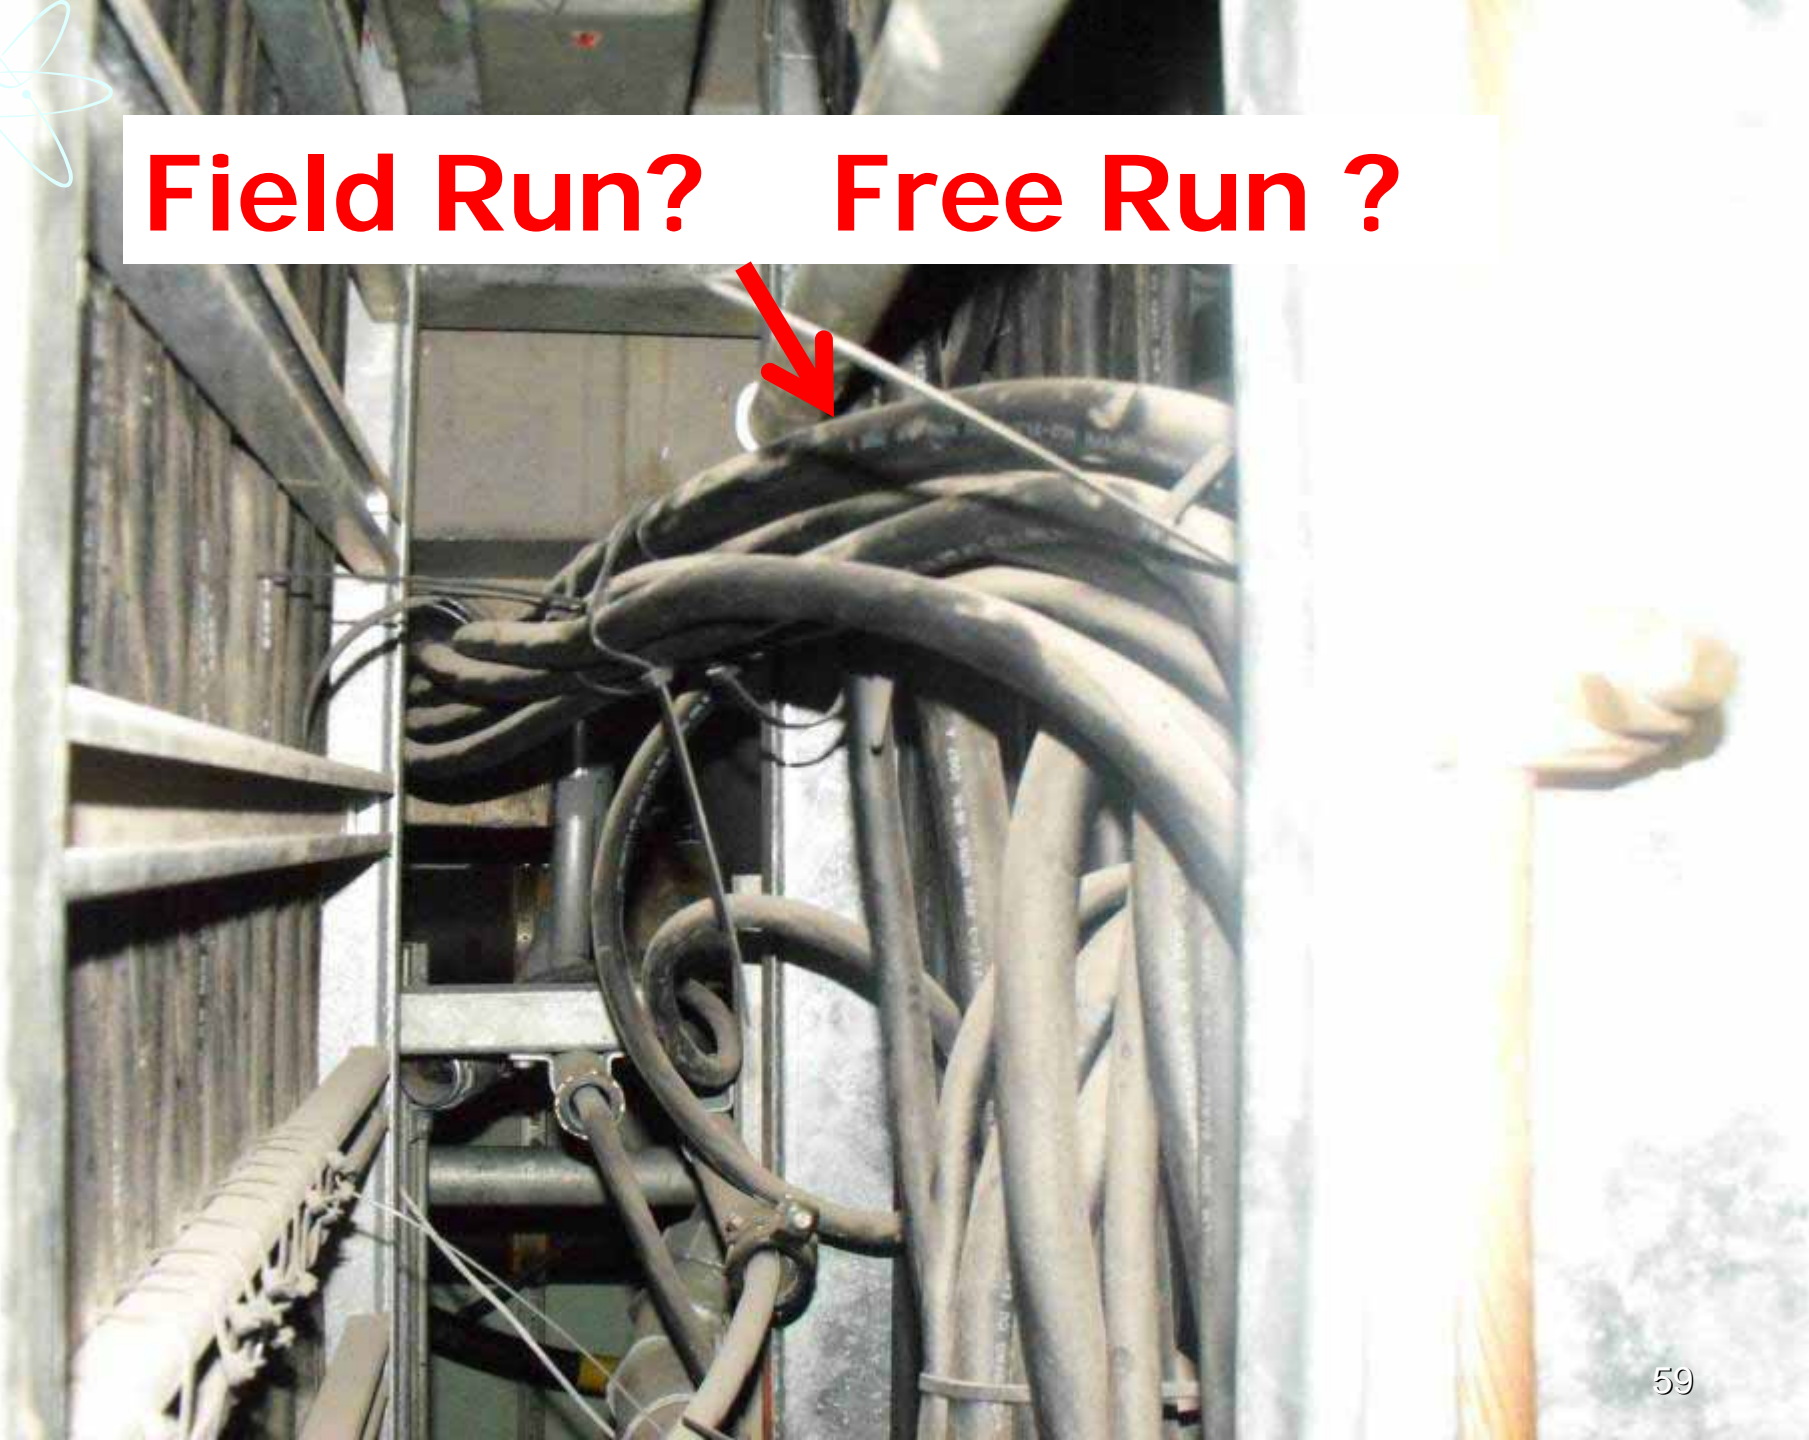
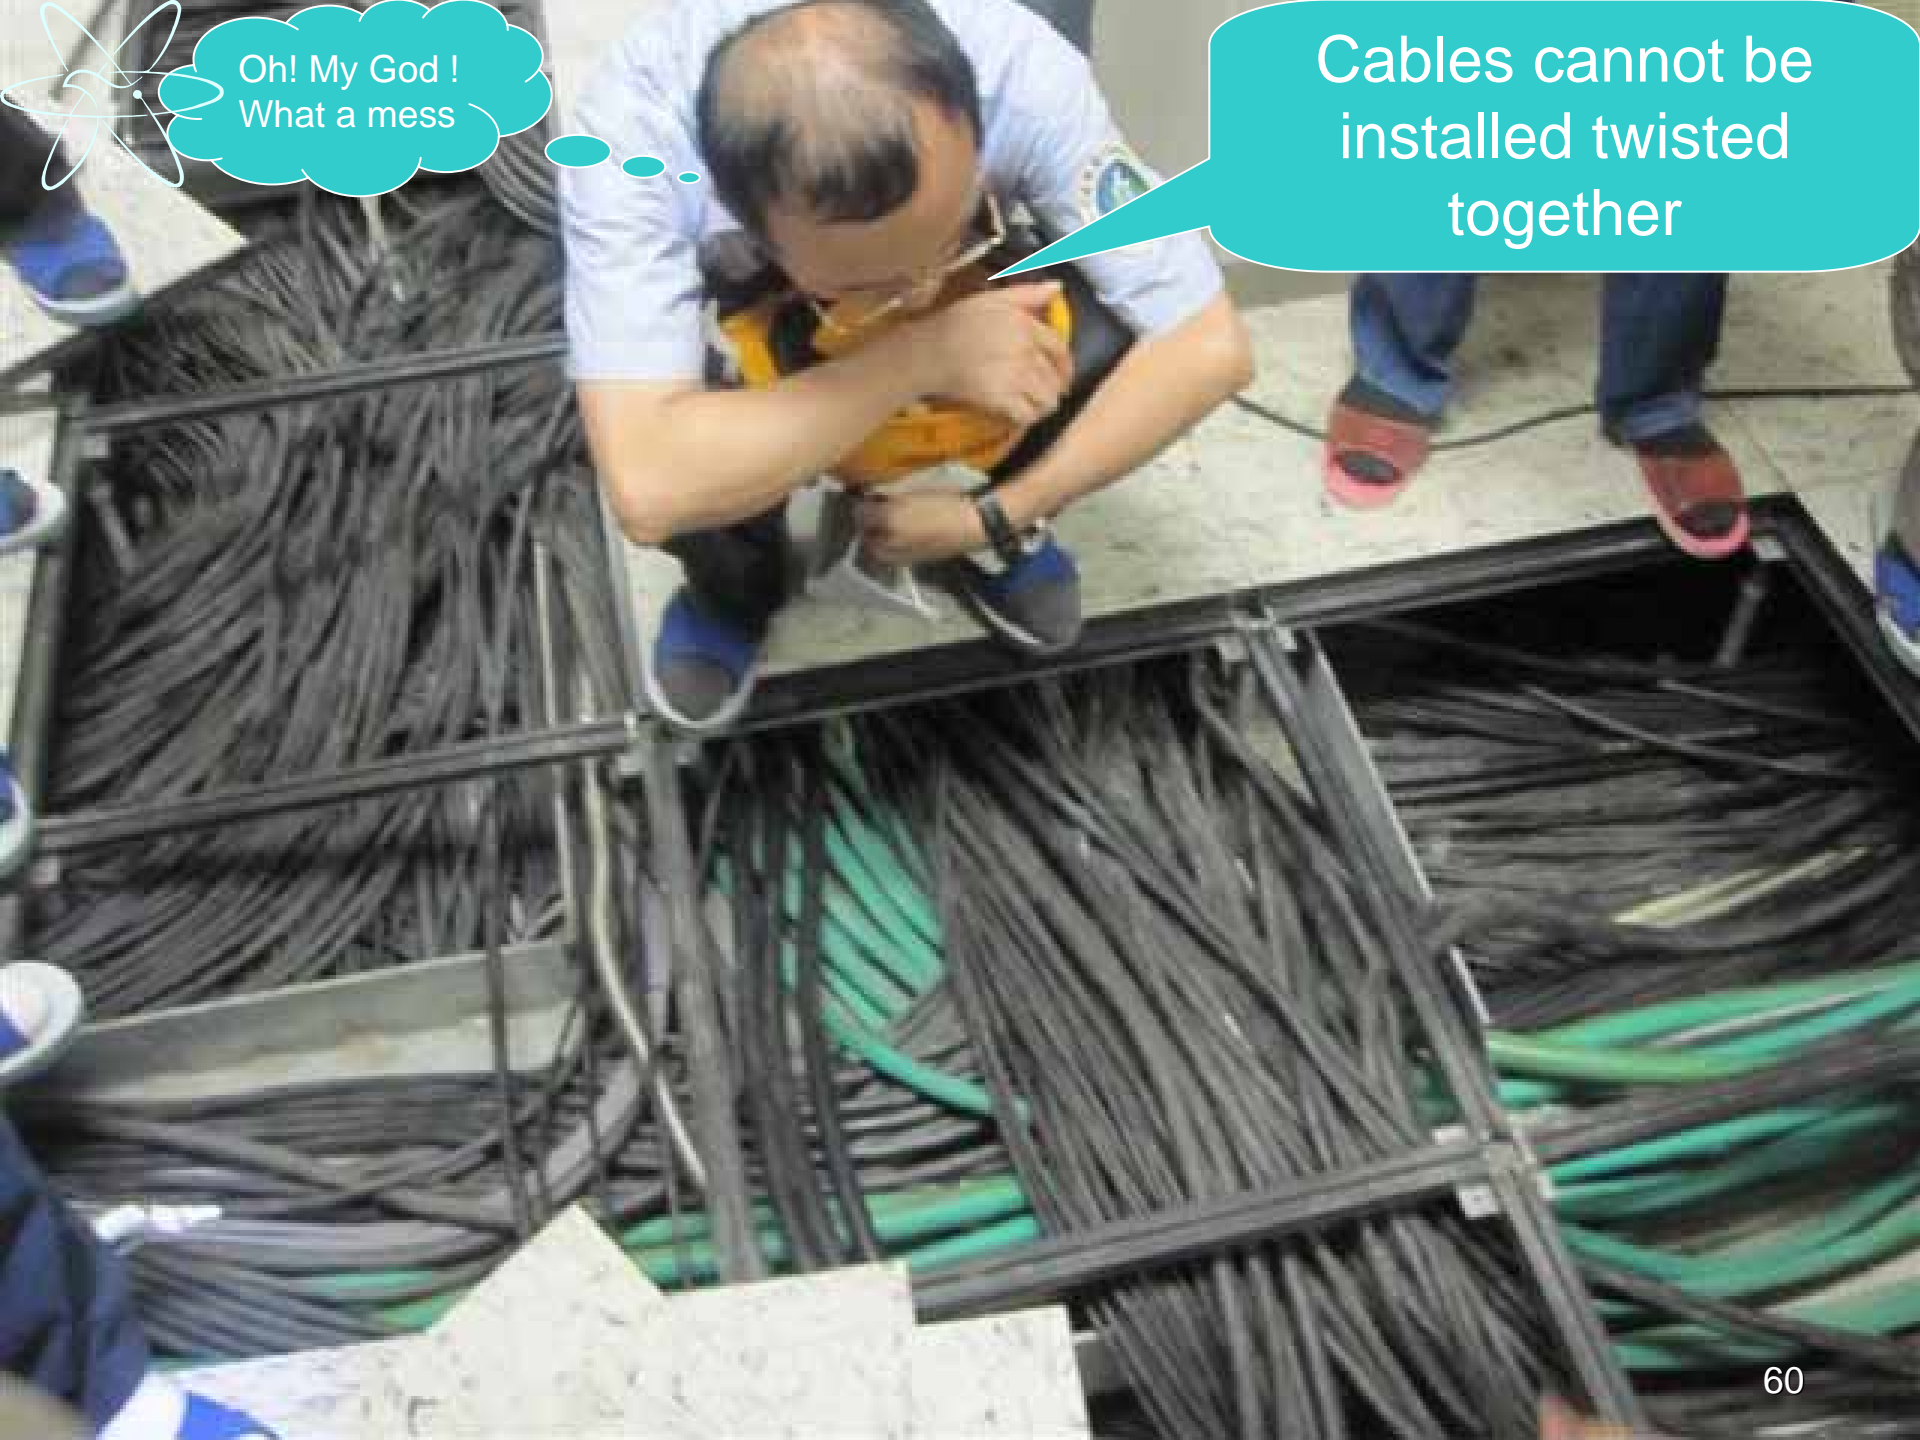
Oh! My God!  
What a mess

Cables cannot be  
installed twisted  
together

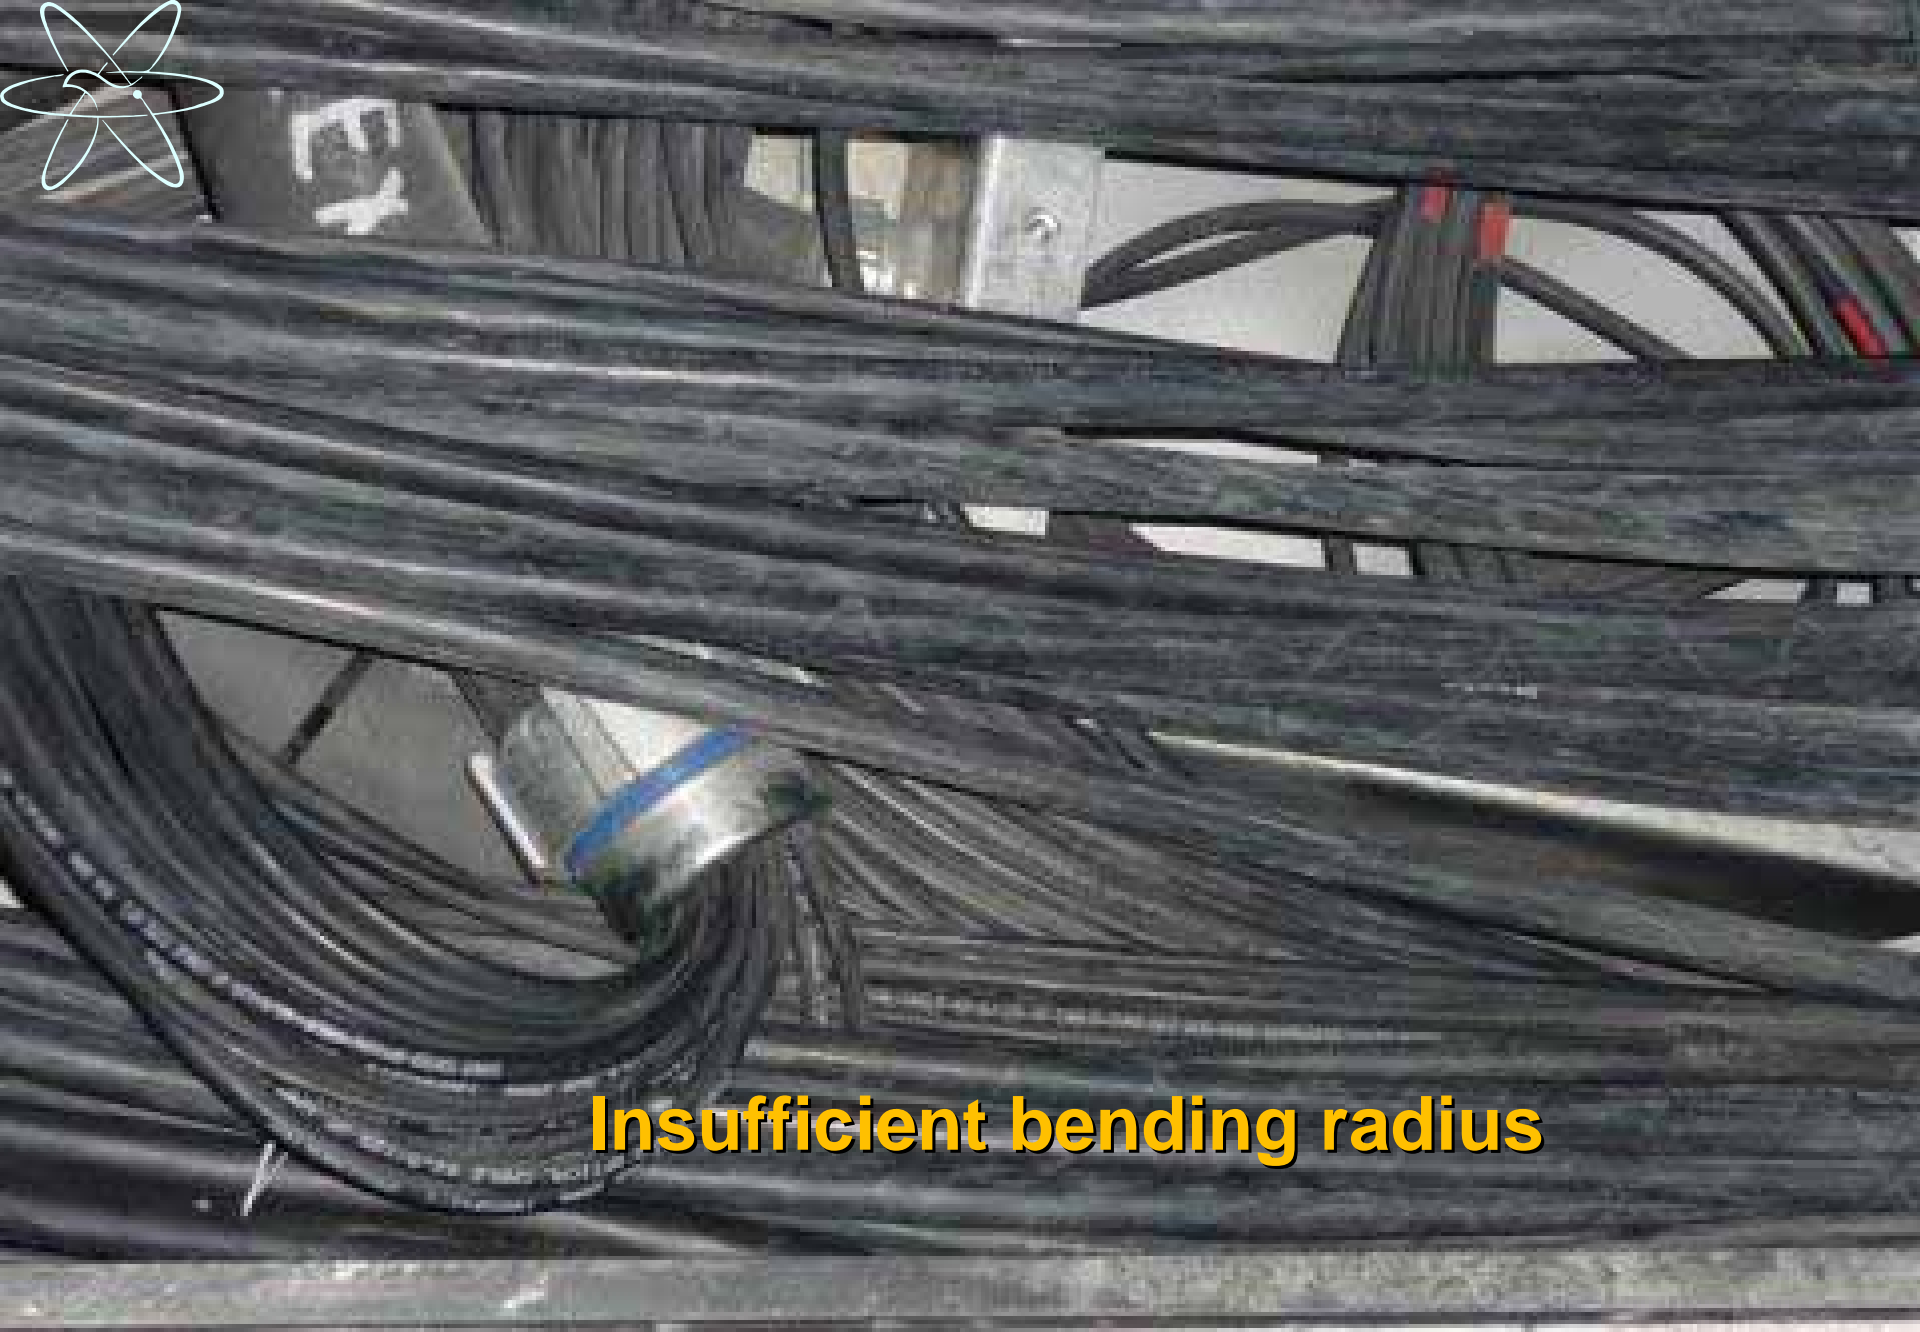
**Insufficient bending radius**

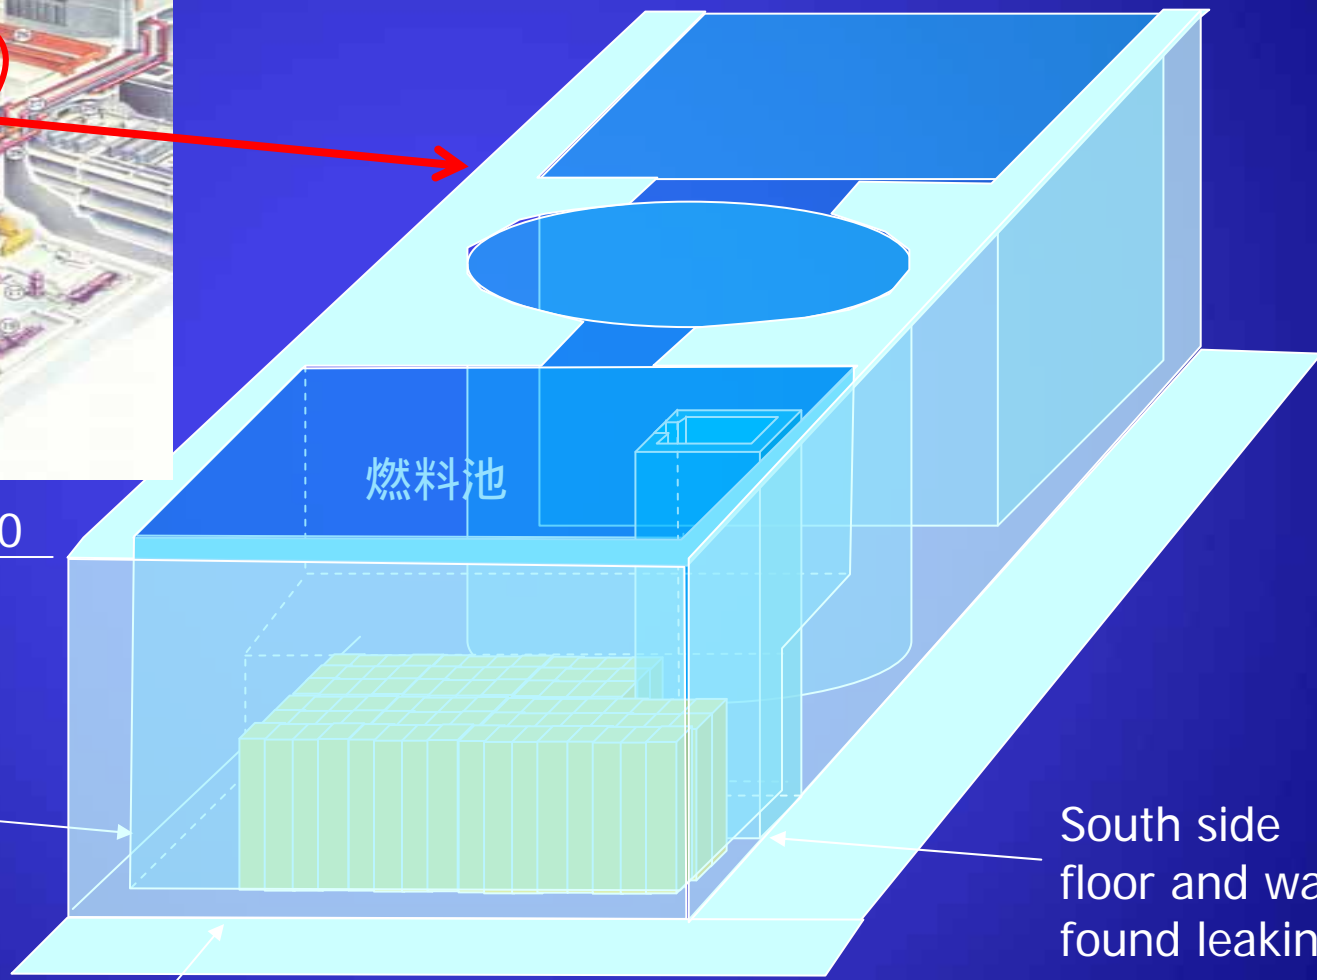
Unistrut on north side wall found leaking water

West side floor found leaking water

South side floor and wall found leaking water

- After scrutiny into this event, some suspicious causes (SFP weld break, pipeline leakage) have been excluded.
- Finally the root cause was identified
  - The welding in SFP overflow channel was not completely done
  - That day RWCU has ever made a SFP level surge and some water flow through the welding open
- Submitted the recovery plan, then welded properly and implemented full water testing

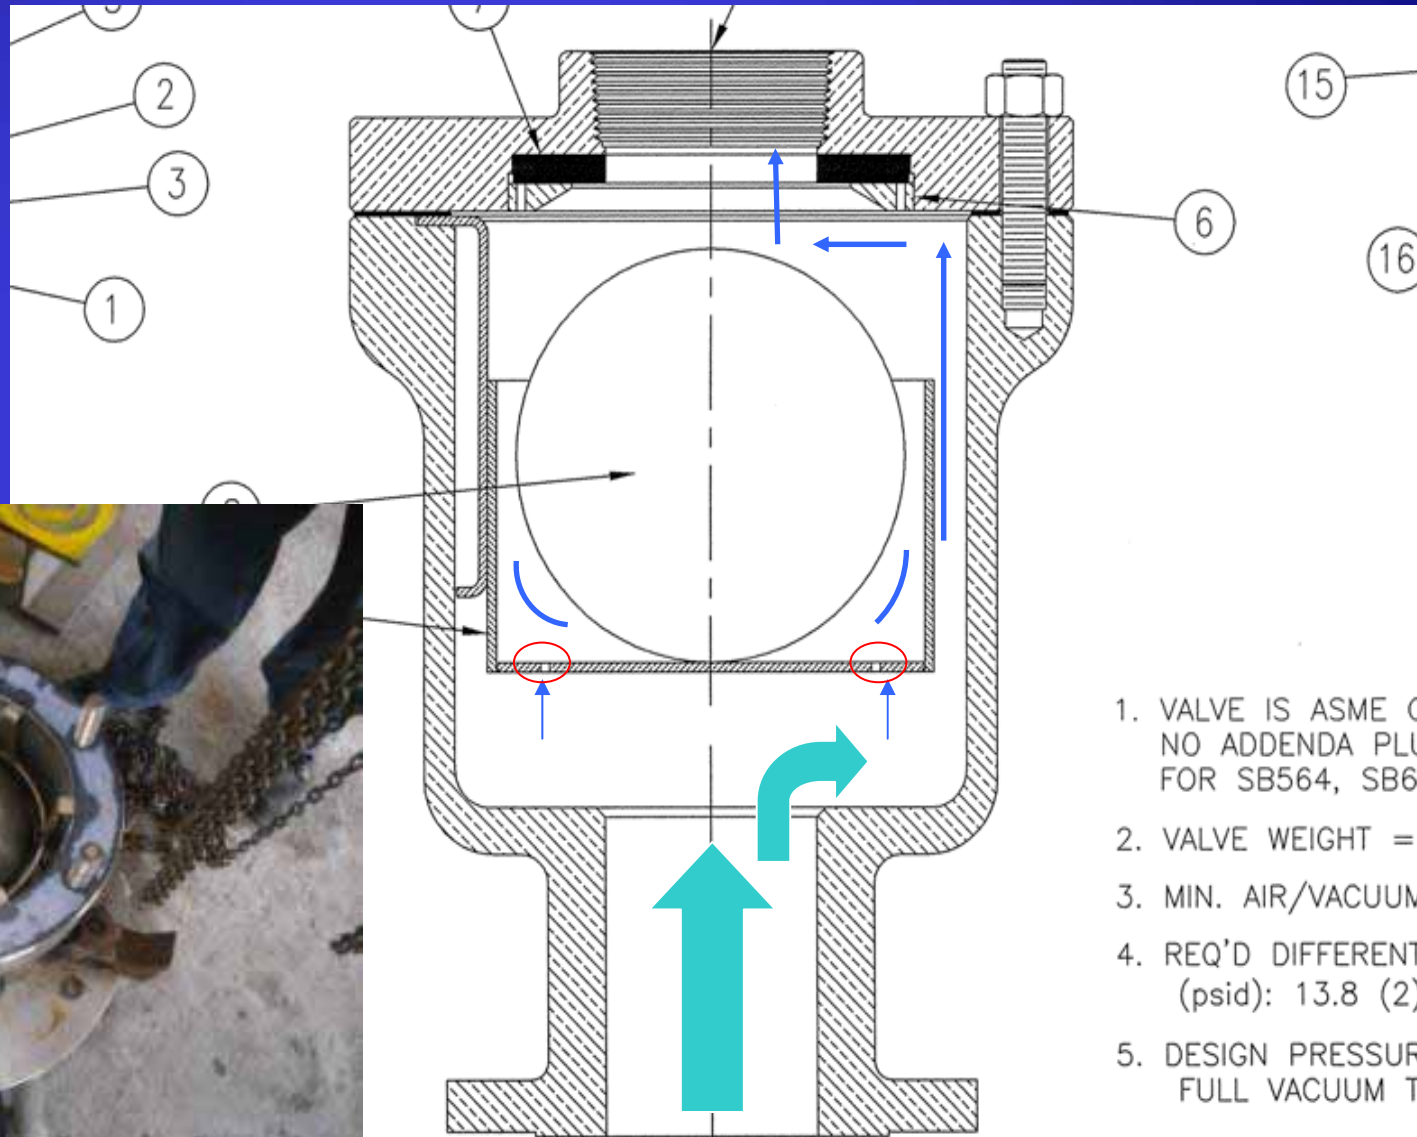
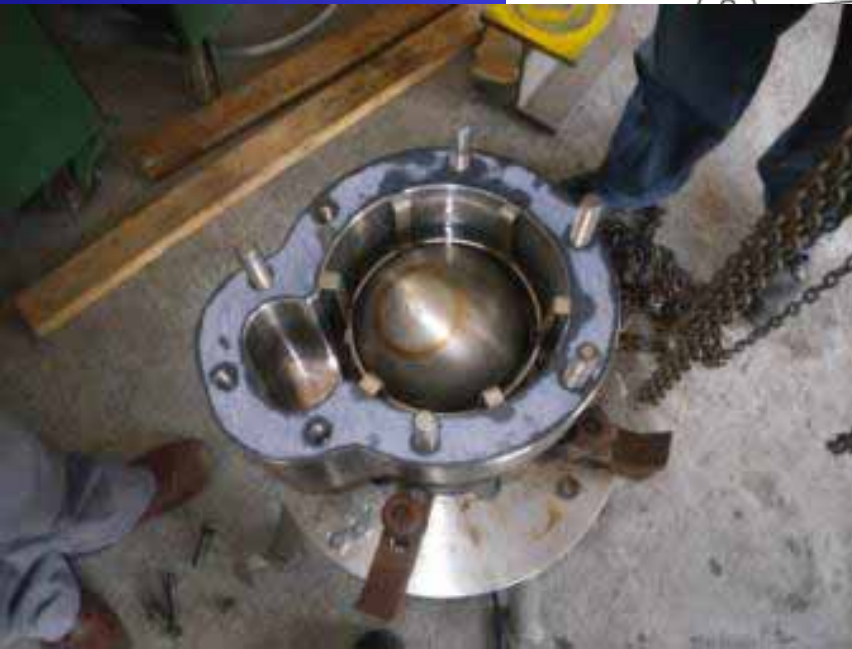
# RBSW air & vacuum relief valve

- Lungmen RBSW system uses automatic air & vacuum relief valves (AVs) to vent air in the seawater piping when the system starts
- Recently some AVs failure to function have been found. The ball inside AV fails to close after the air has been vented, and sea water flow out through the valve
- Since Sept. 2011, three major flooding events have happened at RBSW pump room, piping trench and valve rooms, respectively
- Two violations have been issued by AEC for the RBSW AV problems

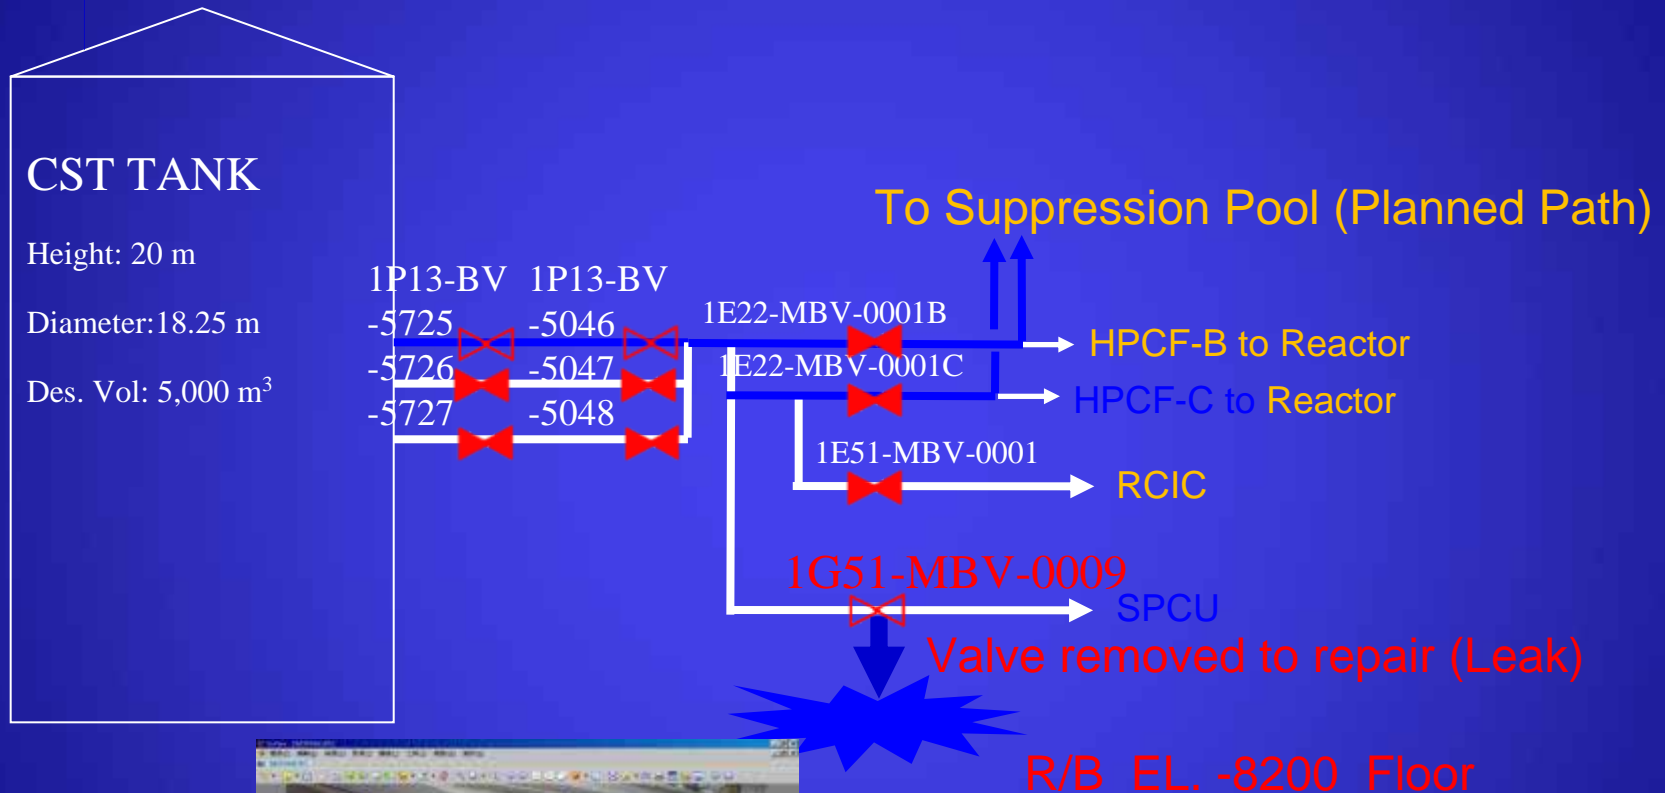
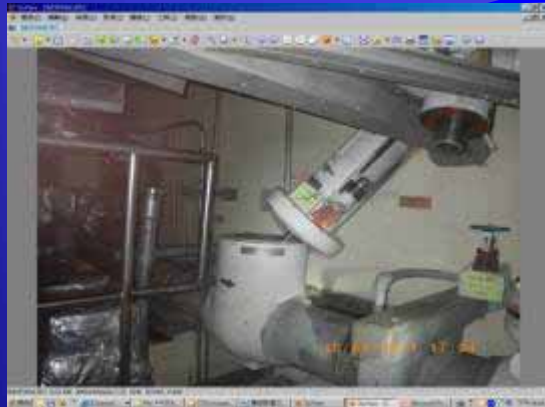
# Reactor Building Flooding (cont.)

- On 8/16/2011, condensate water from CST was used to flood suppression pool, through HPCF piping, to facilitate performing following ECCS pre-op tests
- Condensate water flowed through a removed-for-repaired SPCU valve, which wasn't checked out beforehand, for 14 min., and flooded to the Reactor Building bottom floor
- RB sump Hi-Hi alarm appeared and MCR operator ordered people to shut the water down
- The flooded water level reaches 30 cm (= 12 in.)

- Poor Change Management
- Planning and preparation were not enough
- Poor work coordination and communication
- Tagging was not complete

- Affected equipment were checked, retested, or repaired, and the list is maintained for further verification
- Thoroughly review existing tagging and separation
- Additional training on good working practice
- Revising Tagging Procedure to enhance review, personnel qualification and training
