Taiwan Power Company

Geological Survey for the Sites of Operating Nuclear Power Plants

SINOTECH ENGINEERING CONSULTANTS, LTD.

2013/9/24

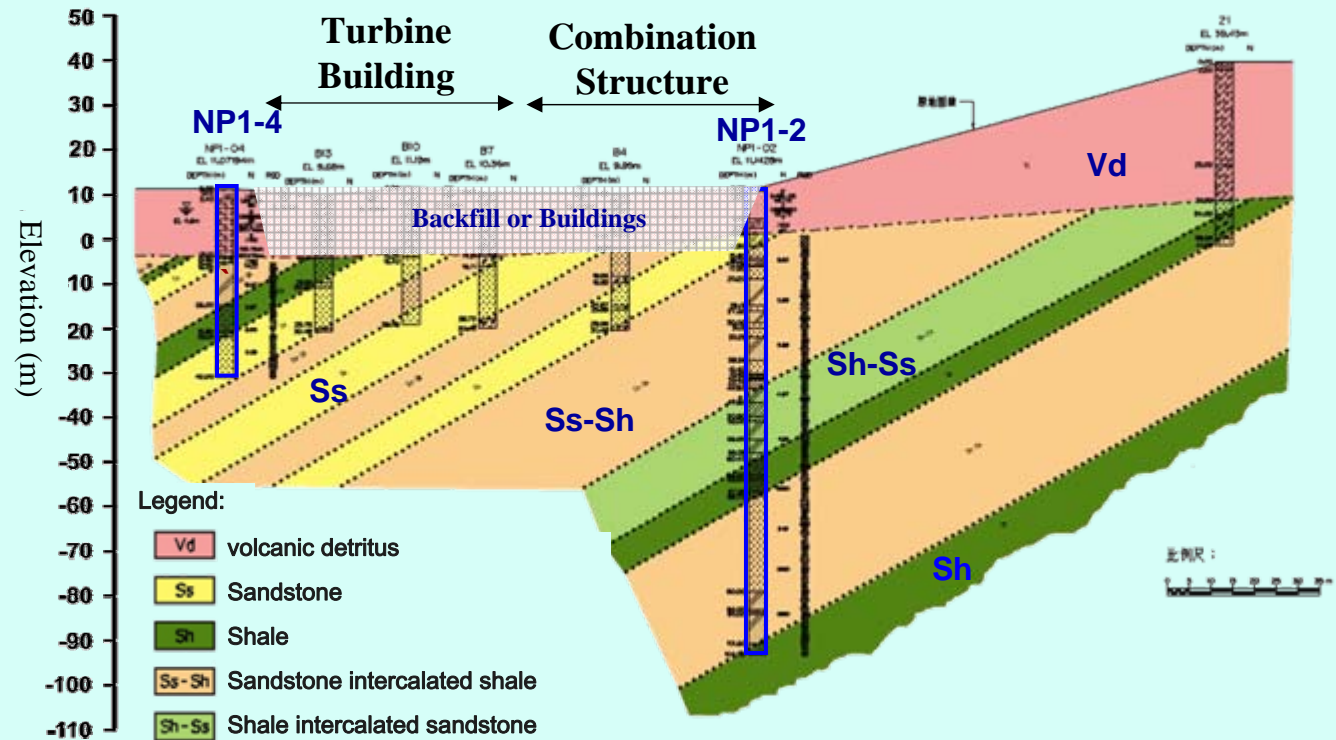
NPP1(Chinshan)

- Stratigraphy and Lithology
 - Unconsolidated sediments : thickness of 2~12m
 - Volcanic detritus (pyroclastic or epiclastic) rocks (Vd) : thickness of 2~14.7m
 - Rockmass : Tapu (or lower Kueichoulin) Formation (Late Miocene)

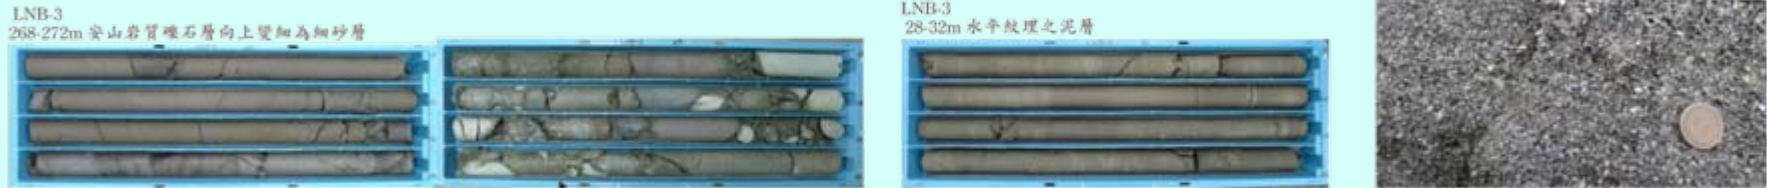
- Shanchiao Fault at Jinshan area (deep borehole drilling)
 - Located between LNB-1 and LNB-3
 - Hanging wall subsidence, dip separation about 518.85m
 - Dipping $>82^\circ$ toward southeastern

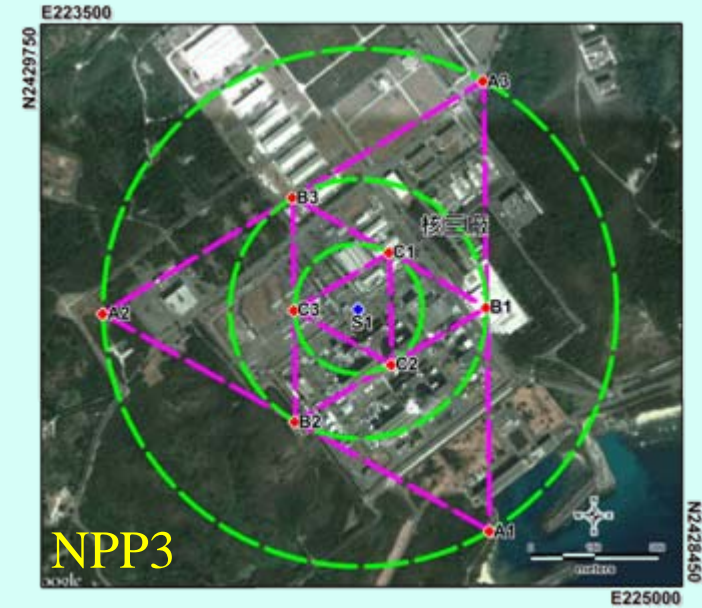
- Estimated the Shear Wave Velocity Structures of NPPs Site from Array Records of Microtremors
