# The unusual events during construction

- #2 RB Flooding during Typhoon SINLAKU
- Rerouting of cables below raised floors
- Spent Fuel Pool Leakage
- RBSW AV Problems
- #1 RB Flooding during testing

## #2 RB Flooding during Typhoon SINLAKU

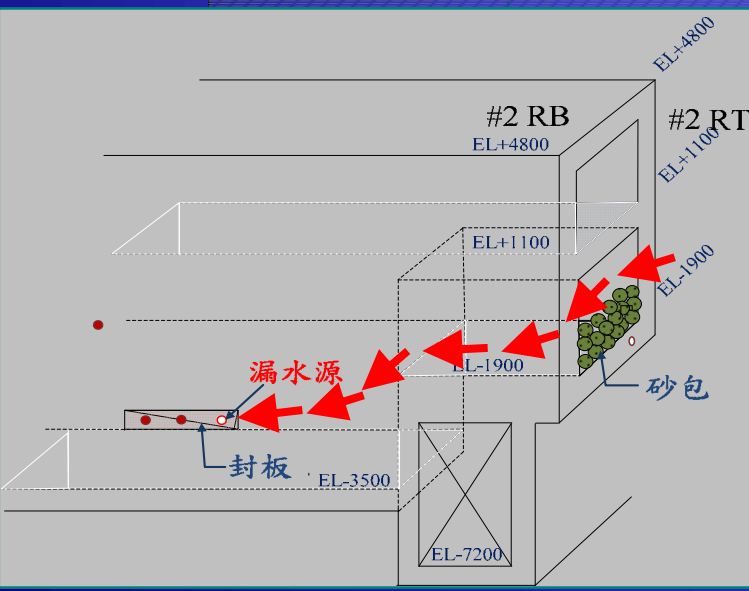
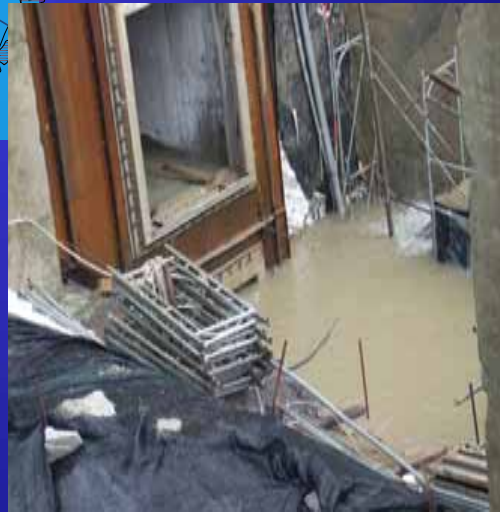
# Typhoon SINLAKU Flooding Path

- On Sep. 13<sup>th</sup> & 14<sup>th</sup> 2008, Typhoon SINLAKU hit the northern Taiwan with strong wind and heavy rains. It caused the flood in the Unit 2 Reactor Building Radwaste Tunnel of the LMNPP, which is still under construction.
- Some of the pumps failed to function due to offsite power outage in the evening of 13<sup>th</sup>. The flood level thus got higher and higher. ( outside of RB )
- The flood overflowed the sand bags and through the poorly sealed pipe ( 6 inches ) towards the RB.

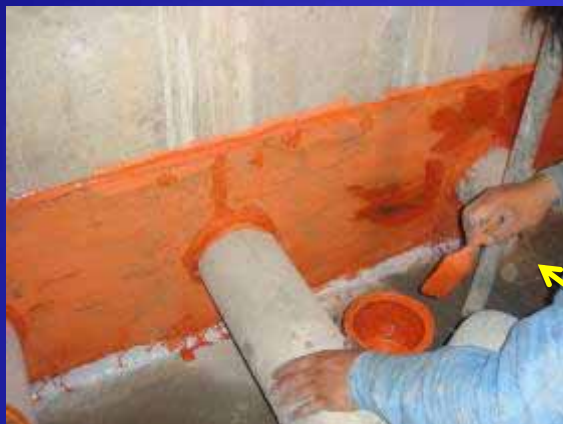
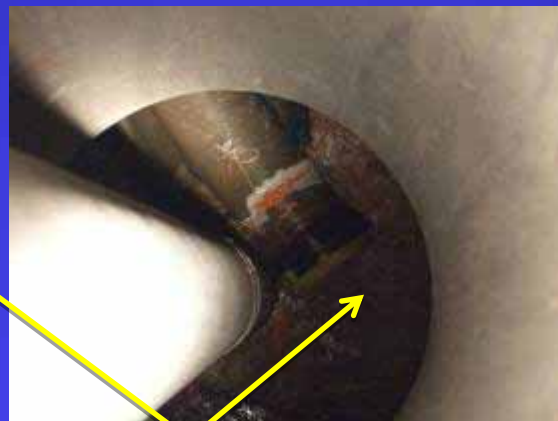
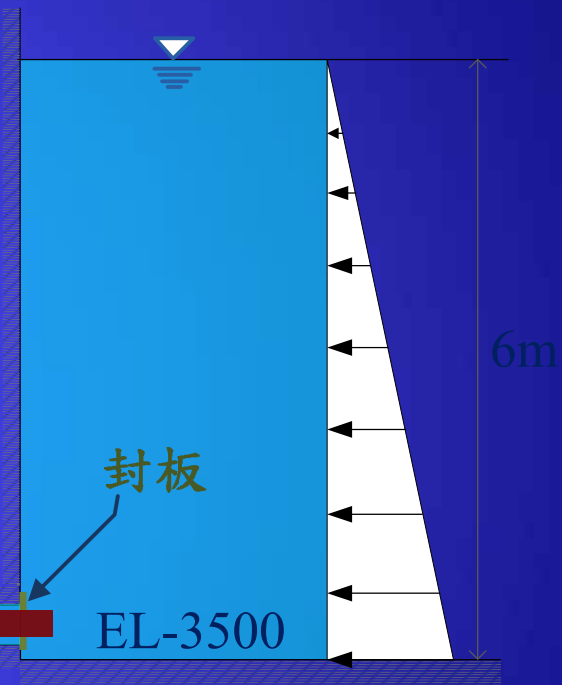
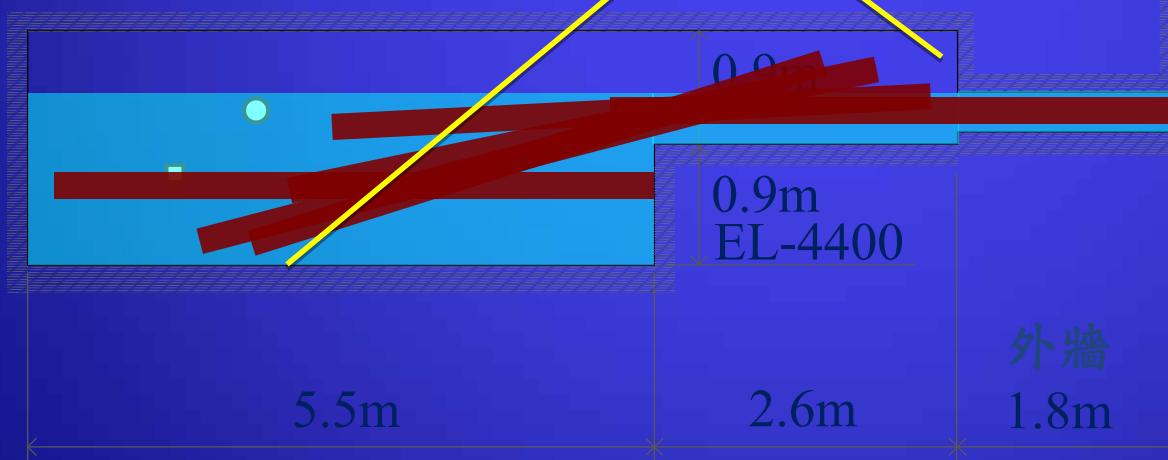
# RB Room 149 Flooding Sketch Map

- The water flew through the hole into the RB, and flooded the pumps ( not submersible pump ) equipped at the basement ( EL. -8200 ) . These 8 sets of non-submersible pump failed to function.
- The flood level eventually reached about 2 meters. ( inside of RB )

- All affected equipment have been repaired according to the recovery plan
- TPC established 「 Special maintenance plan before turnover 」 ( including Post Construction Test phase )
- TPC set up 「 Special maintenance plan after turnover 」 ( including Pre-operation test, Startup test, commercial operation phase )
- Evaluate the PCT, Pre-op, Startup test result
- Enhanced supervision for at least 2 cycles after commercial operation
- **Ensure the affected equipment can perform its intended safety function not only in testing phase but also in operating phase**

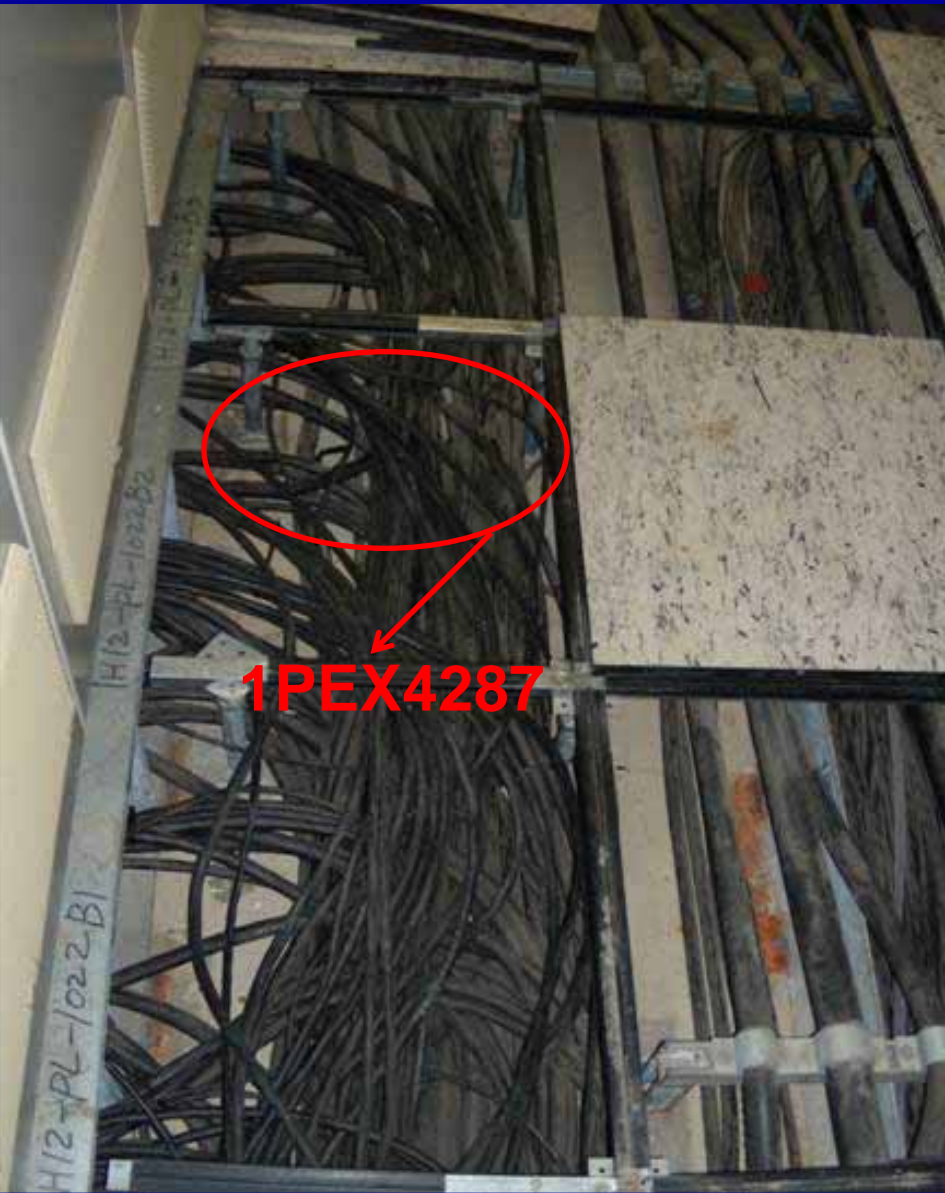
**CB 12300 RM591, before**

- Limited space for cable raceway.
- Lack of cable spreading room.
- Deficiencies in installation of field run cable
  - No separation of instrument cables from control or power cables will introduce potential EMI problems.
  - Defects in separation between different divisions of safety related cables and between safety related cables and non-safety related cables

- **Corrective actions:**
  - Rerouting/Rearrangement Plan taken immediately
  - Re-inspection of cable installation in other areas
  - Enhance the training and experience feedback for workers.
  - Modifying the procedure for inspection of cable installation.
- **AEC requested TPC to conduct a review from various aspects including design, construction and installation, inspection, personnel training, engineering management and organizational culture, etc., and to investigate the cause for the defects, and submit feasible improvement plans and thoroughly implement them.**

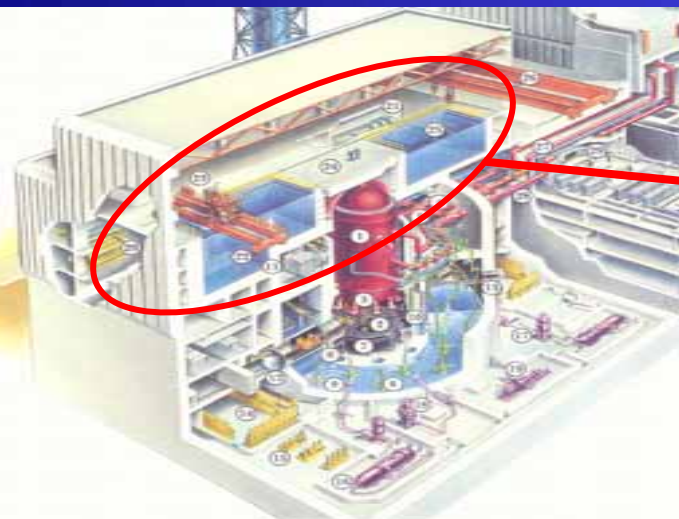
- On 7/19/2011, SFP liner leakage detection piping level high alarm appeared, and suspicious water found on lower floor
- The leakage detection piping monitoring SFP bottom floor welding was full of water and the leakage rate reached 2.5 L/min
- Leaking water was found on south, north, and west side walls of SFP
- SFP weldings passed all VT, PT and VBT
- SFP passed full-water test

Unistrut on north side wall found leaking water

West side floor found leaking water

South side floor and wall found leaking water

- After scrutiny into this event, some suspicious causes (SFP weld break, pipeline leakage) have been excluded.
- Finally the root cause was identified
  - The welding in SFP overflow channel was not completely done
  - That day RWCU has ever made a SFP level surge and some water flow through the welding open
- Submitted the recovery plan, then welded properly and implemented full water testing

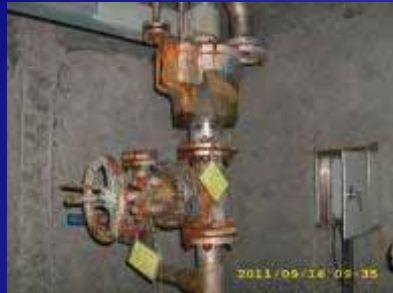
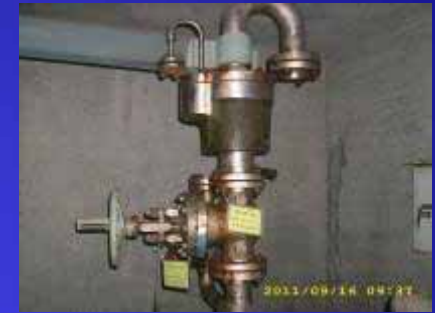
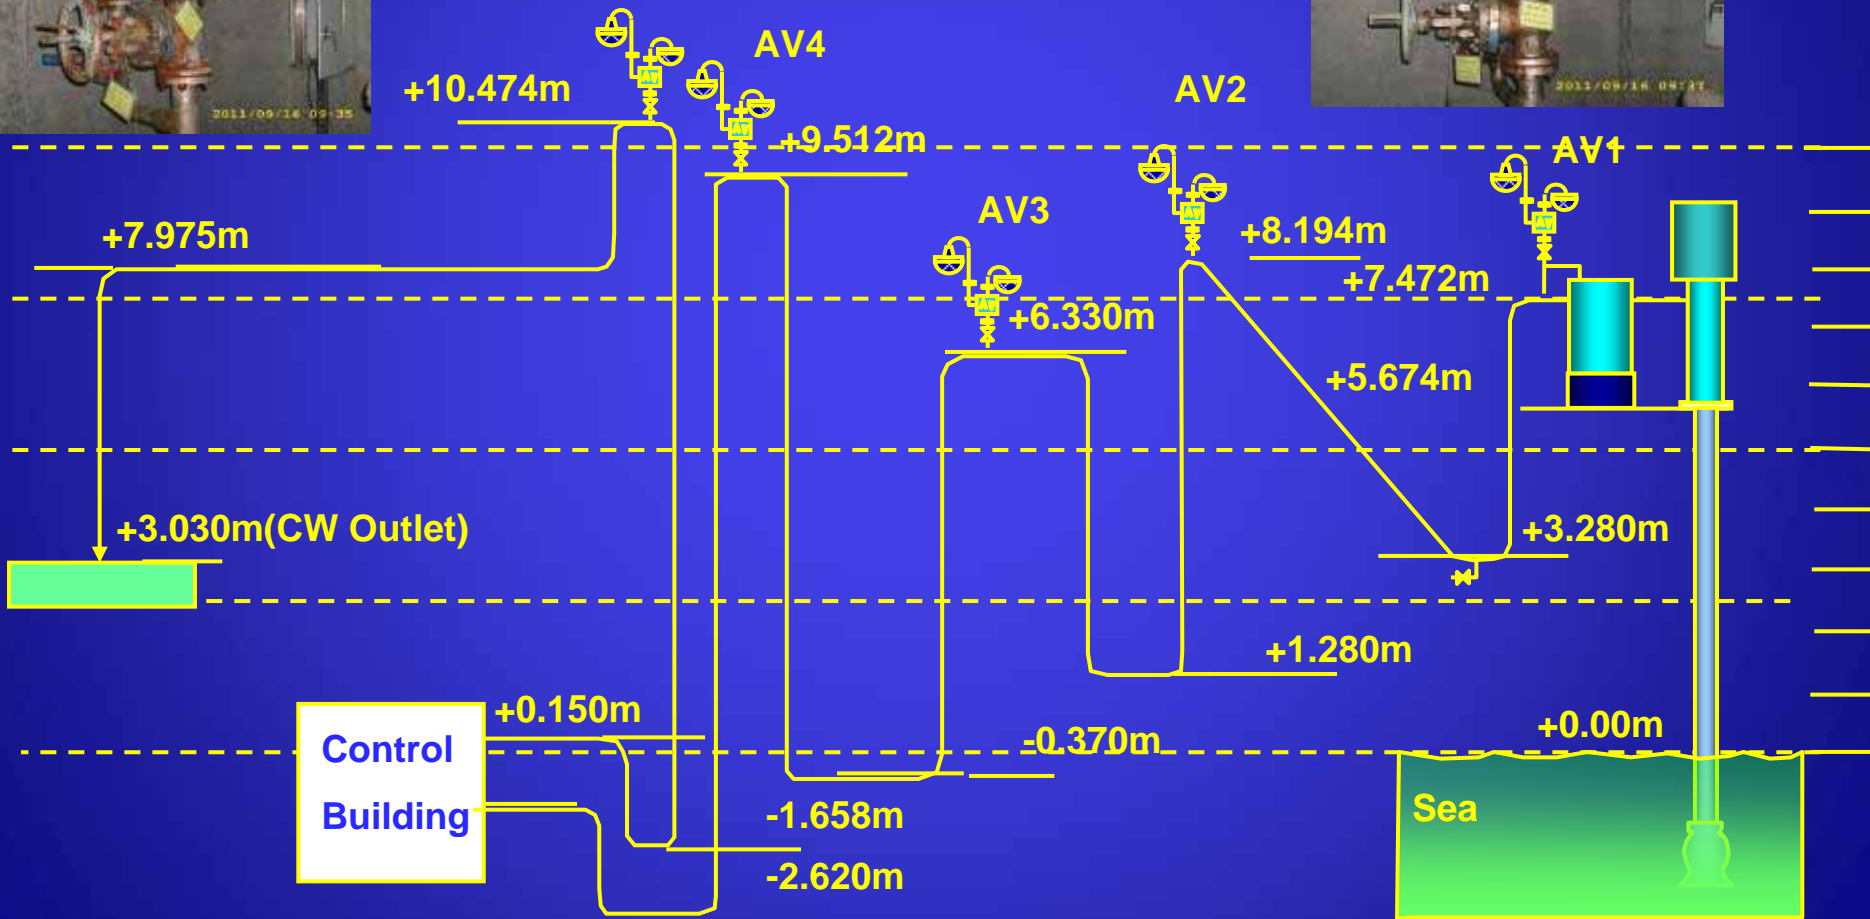
# RBSW Waterway Elevation and AV Locations

- Lungmen RBSW system uses automatic air & vacuum relief valves (AVs) to vent air in the seawater piping when the system starts
- Recently some AVs failure to function have been found. The ball inside AV fails to close after the air has been vented, and sea water flow out through the valve
- Since Sept. 2011, three major flooding events have happened at RBSW pump room, piping trench and valve rooms, respectively
- Two violations have been issued by AEC for the RBSW AV problems
