# Review of Implementation of the Plan of Strengthening Nuclear Safety in Lithuania

Head of Safety Analysis Division of the State Nuclear Power  
Safety Inspectorate (VATESI)

- ❖ **General information about nuclear facilities in Lithuania**
- ❖ **Current state of Ignalina NPP units**
- ❖ **Approval of the updated NAcP and transparency**
- ❖ **Implementation of the NAcP measures**
- ❖ **Status of the NAcP since the 2013 NAcP workshop**
- ❖ **Conclusions on implementation of NAcP**
- ❖ **Answers to the questions to the updated NAcP**

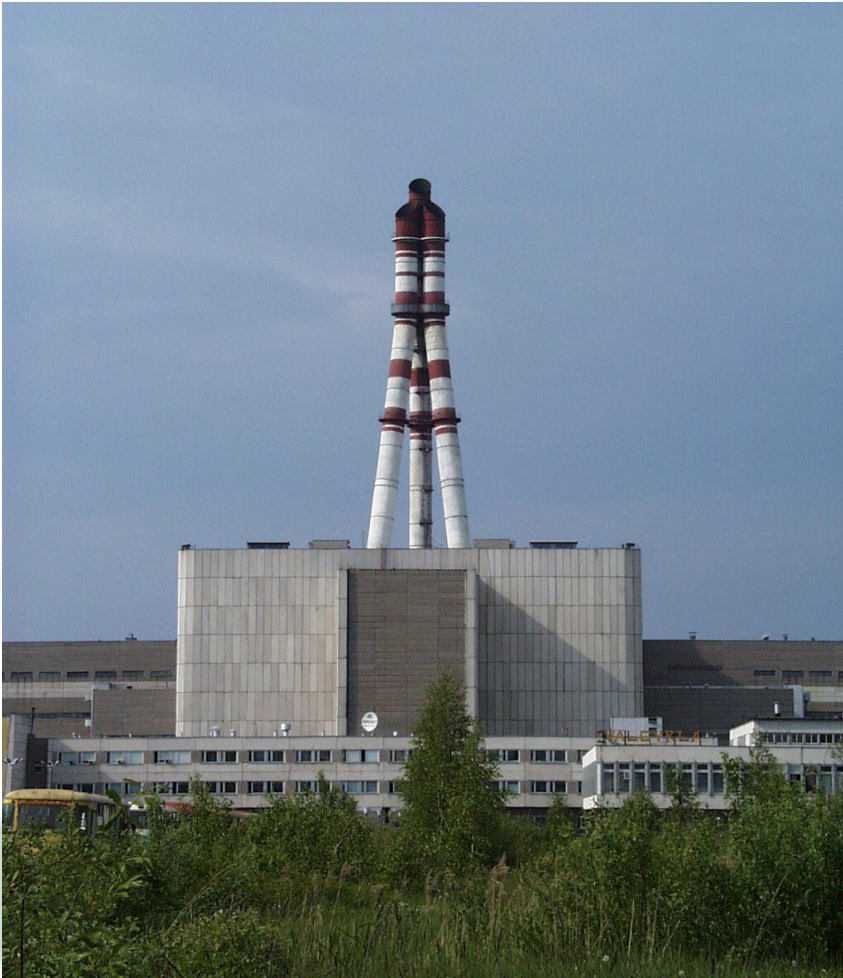
# REACTOR RBMK-1500

## RBMK-1500:

- Channel type graphite moderated boiling light water nuclear reactor
- Design power – 4800 MW(th), authorized power – 4200 MW (th)
- The only two units were built (both at Ignalina site)

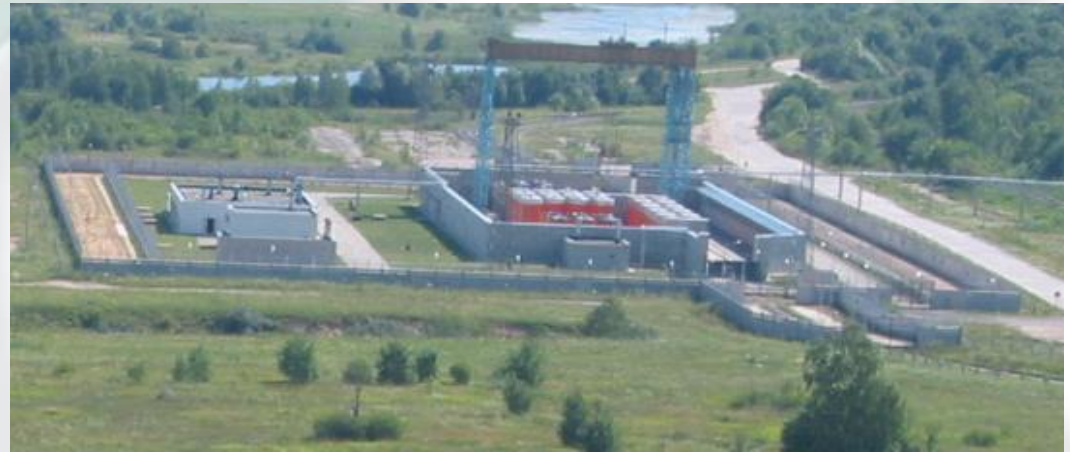
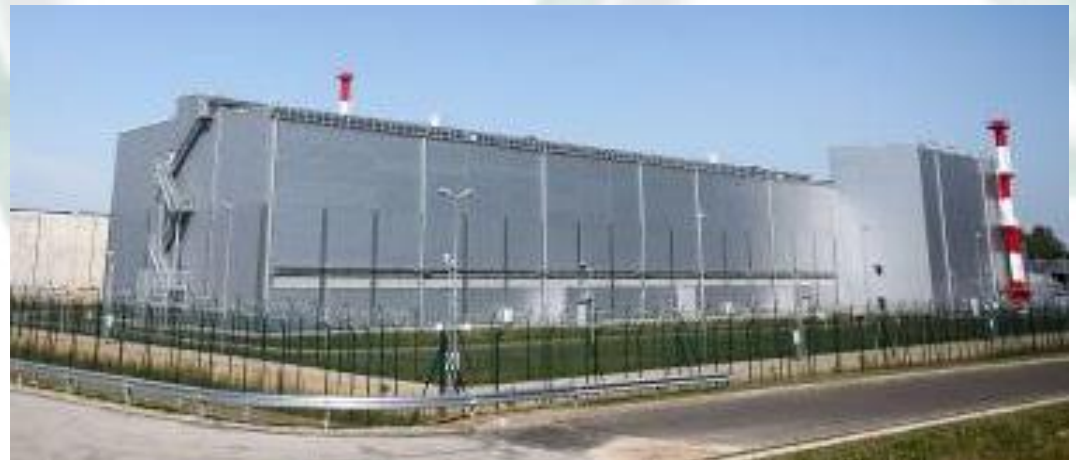
## MEASURE NR. 9 – ASSESSMENT OF EMERGENCY REMOVAL AND REPAIR WORK AT DRY TYPE SPENT NUCLEAR FUEL STORAGE FACILITIES (1)

- ✿ Finished just before NAcP Workshop in 2013
- ✿ Reviewed postulated collapses of structures of interim dry type spent nuclear fuel storage facilities (of old and new one) due to beyond design earthquake

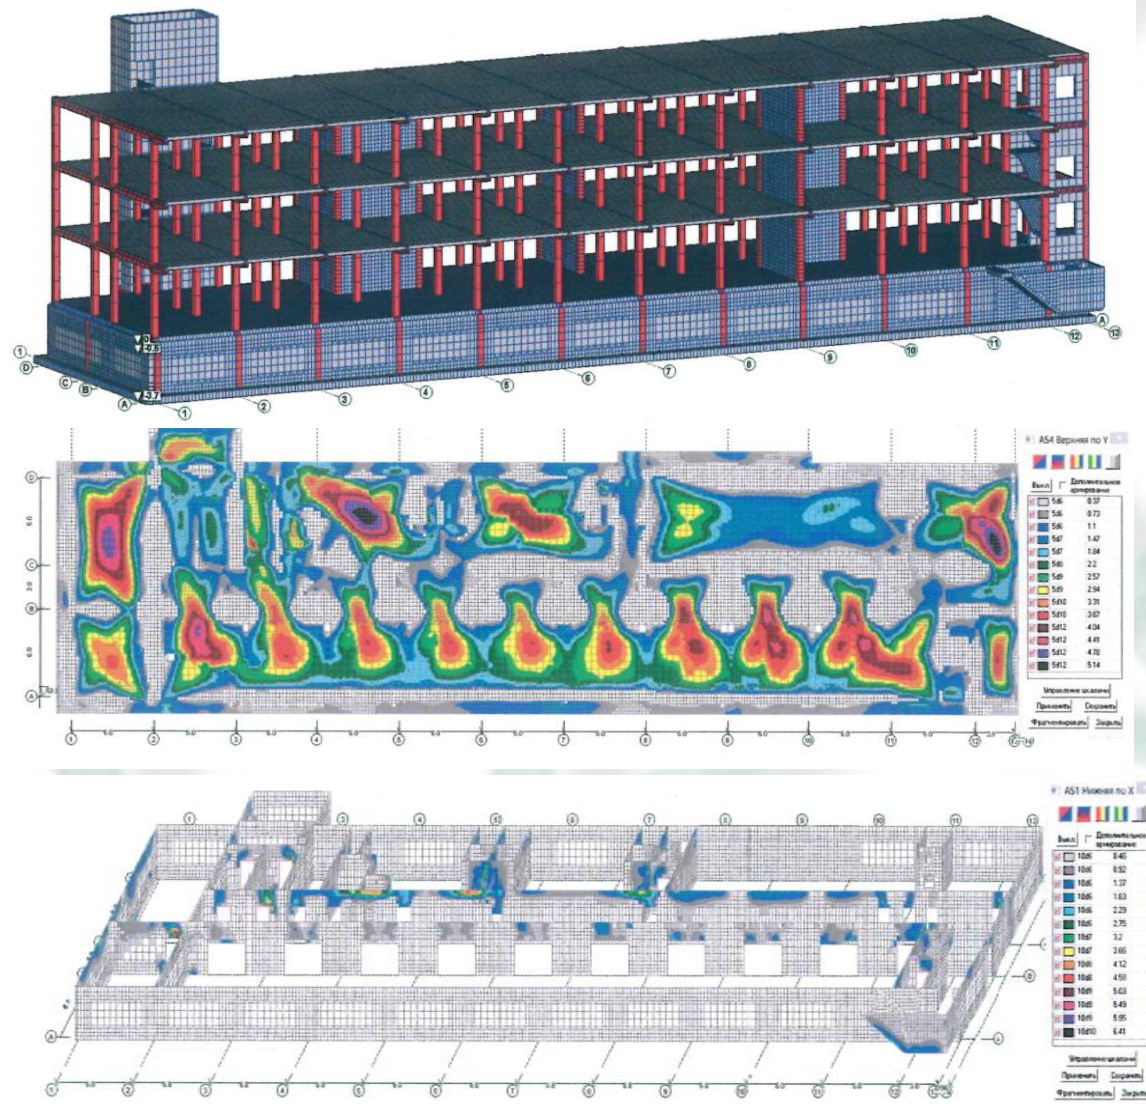
# MEASURE NR. 6 – ASSESSMENT OF ROBUSTNESS OF AMC AGAINST AN EARTHQUAKE (1)

✱ Analysis was performed for building structures, related to Accident Management Centre of Ignalina NPP (AMC)

✱ Additional assessment for robustness of top plate of AMC against falling structures, possibility and possible clogging of AMC emergency exit by debris of the near buildings was done as well

✱ Main results of analyses:

- AMC will withstand seismic event with  $PGA=0,13g$
- AMC will not withstand seismic event with  $PGA=0,2g$
- No clogging of AMC emergency exit by debris

No.	Country/ Organization/ Person asking question	Question	Answer
9.	Ukraine	Could you please explain, whether it means that seismic analysis is performed directly for the AMC building? Does the analysis include assessments of seismic resistance of equipment and communications of AMC or only of the building?	<p>The current analysis was performed only for building structures, as it was planned in the NAcP. Additional assessment for possible clogging of AMC emergency exit by debris of the near buildings was done as well. A few additional recommendations for new analysis were provided by contractor, they were analyzed by Ignalina NPP. The plan of measures is issued in accordance with the recommendations (not included in NAcP). The plan includes:</p> <ul style="list-style-type: none"> <li>- visual inspection of structures of AMC (already done);</li> <li>- decisions on detailed (instrumental) investigation of structures of AMC and further supervision of the AMC structures;</li> <li>- further investigation of AMC emergency exit reliability and decision on possible strengthening of AMC emergency exit;</li> <li>- <u>evaluation of technical documentation, inspections and further decisions on equipment of AMC in order to ensure the habitability of AMC in case of beyond design earthquake (term for implementation of the measure – 2015-07-30).</u></li> </ul>
